# Flooding and Dynamic Beach Hazard Delineation Town of Wasaga Beach

**Shoreplan  
Engineering Limited**

**March 2017**

**LSSEGBCUF Flood and Dynamic Beach Hazard Delineation  
Town of Wasaga Beach**

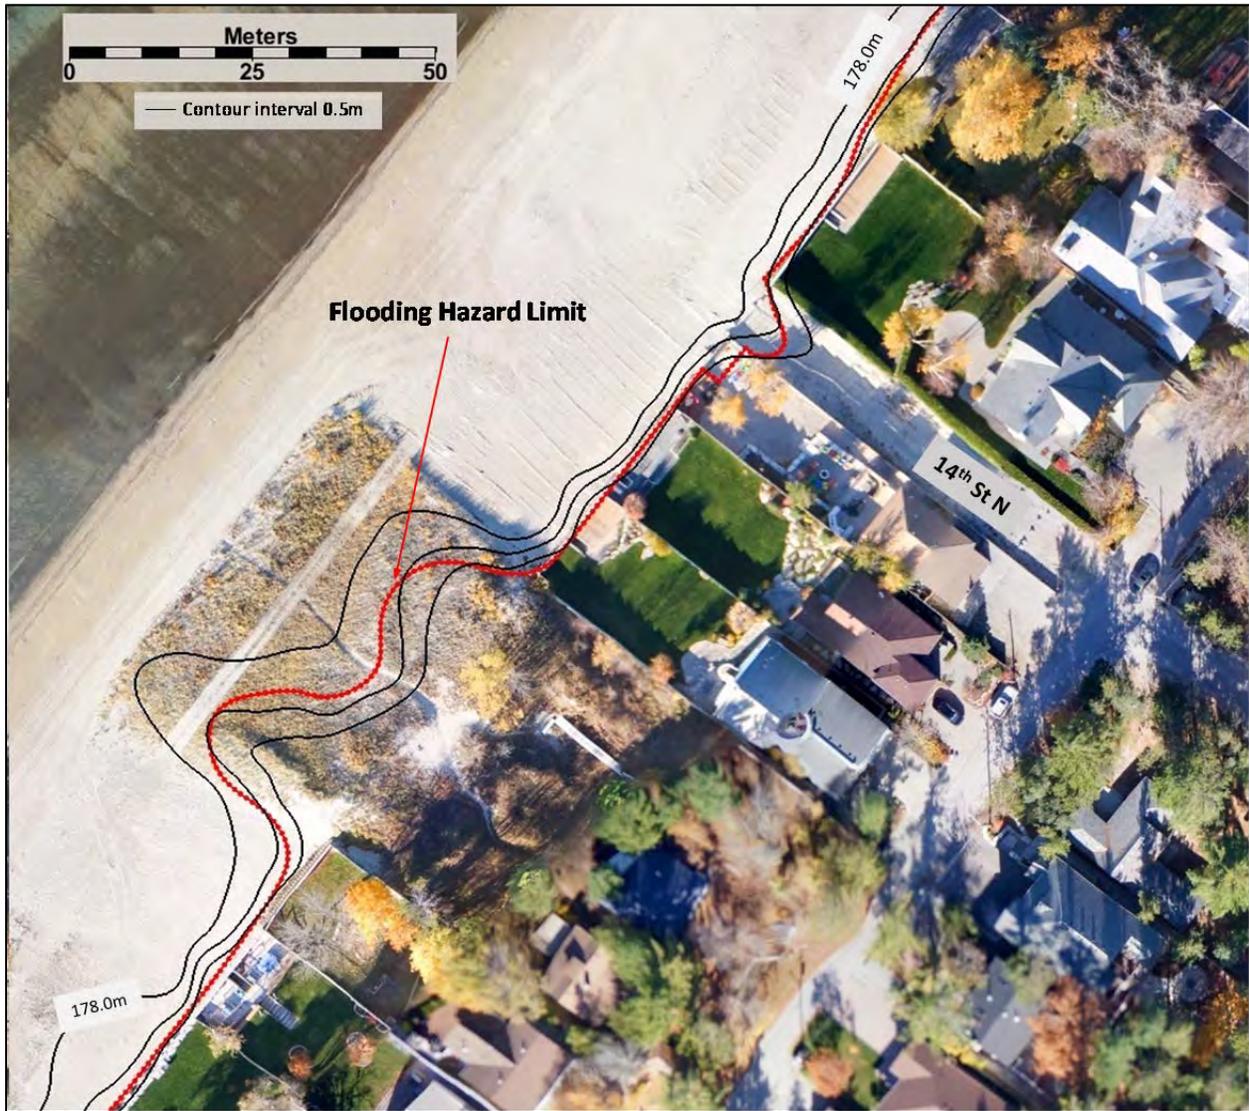
Figure 3.4 Example of Flooding Hazard Limit Mapping

The limit of wave uprush, calculated as described above, defines the flooding hazard for the study area. The flooding hazard limit was digitally mapped and provided to NVCA as a GIS shapefile. Figure 3.4 shows an example of the flooding hazard limit superimposed on the provided orthorectified aerial photographs. It also shows the 178.0m, 178.5m, and 179.0m contour lines derived from the supplied topographic data. Figure 3.5 shows photographs of most of the shoreline covered by Figure 3.4. Those photographs were taken during our field review.

Figure 4.5 shows an example of the dynamic beach hazard limit mapping. This is the same section of shoreline that was used to show the flooding hazard mapping in Figure 3.4. Figure 4.5 shows the flooding hazard limit, the 30m offset to the flooding hazard limit, and the dynamic beach hazard limit. The dynamic beach hazard limit either side of 14<sup>th</sup> Street is defined by the practical limit associated with the existing protection walls (top two photographs in Figure 3.5). On the west side of 14<sup>th</sup> Street the dynamic beach hazard line is actually lakeward of the flooding hazard line because the wall that limits dynamic beach profile adjustments is overtopped, and the flooding hazard limit is therefore landward of the wall.

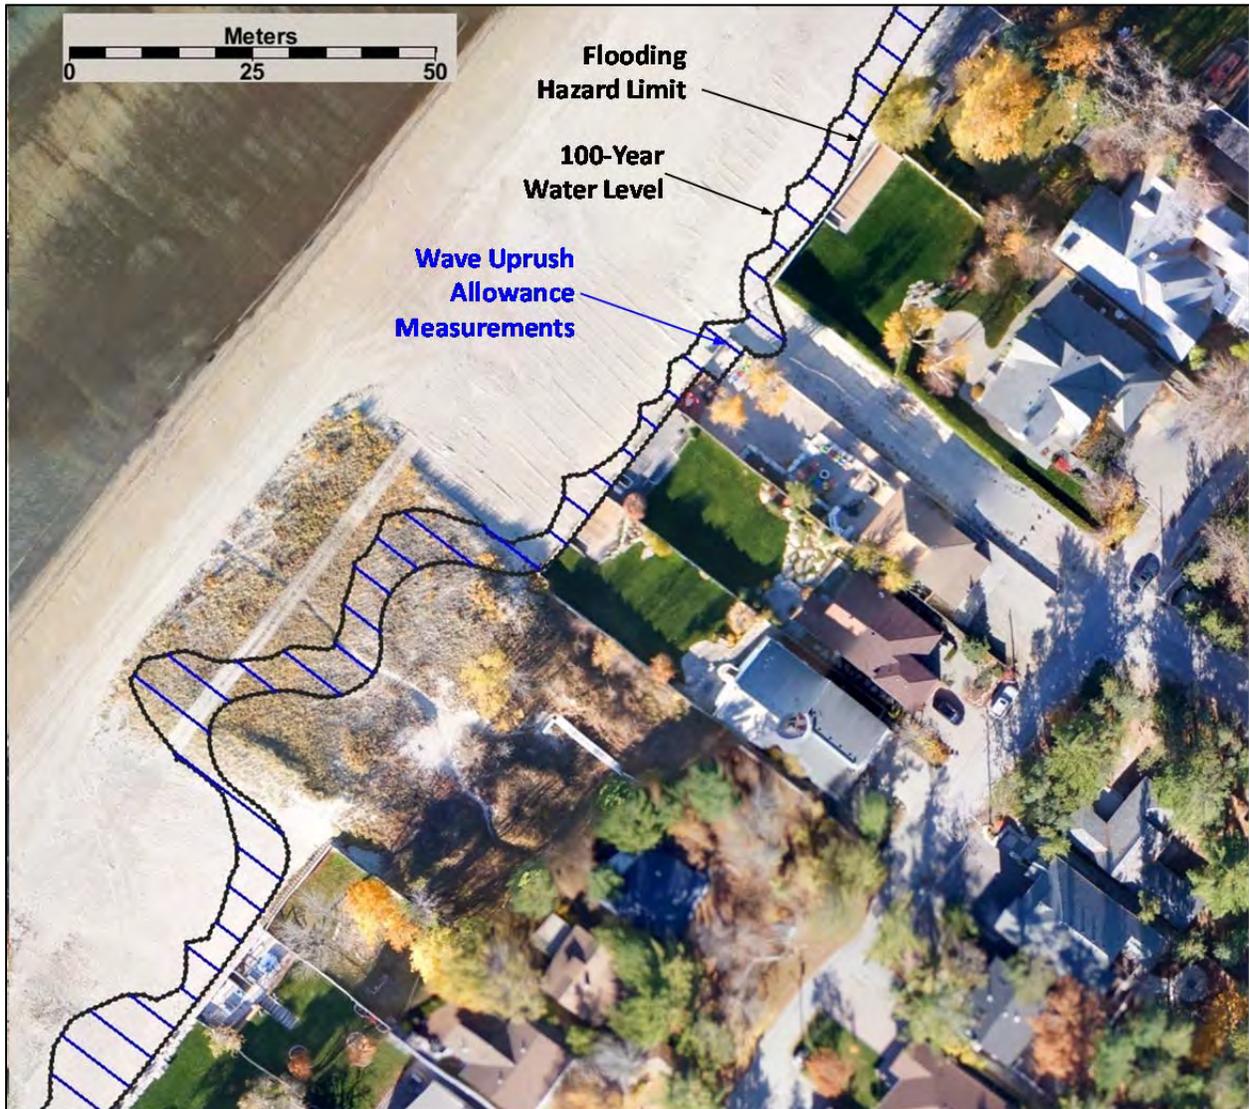
**Figure 3.7 Example of Wave Uprush Allowance Measurements**

NVCA currently assumes a 15m wave uprush allowance, which is the default allowance described by MNR (2001). We measured the mapped wave uprush allowance at 5m metre intervals for most of the dynamic beach shoreline, excluding creek and culvert outlets where curvature of the 178m contour (100-year instantaneous water level) made the measurements unrealistic. Figure 3.7 shows an example of the wave uprush measurements for the same location used in Figures 3.4 to 3.6. A total of 2,747 measurements were made with the wave uprush allowance varying between 2 and 45 metres. Only 115 measurements (4% of total) were greater than 20 metres, and those occurred where the backshore was either flat or sloped down from the beach crest, such as along portions of Eastdale Drive and Coastline Drive.

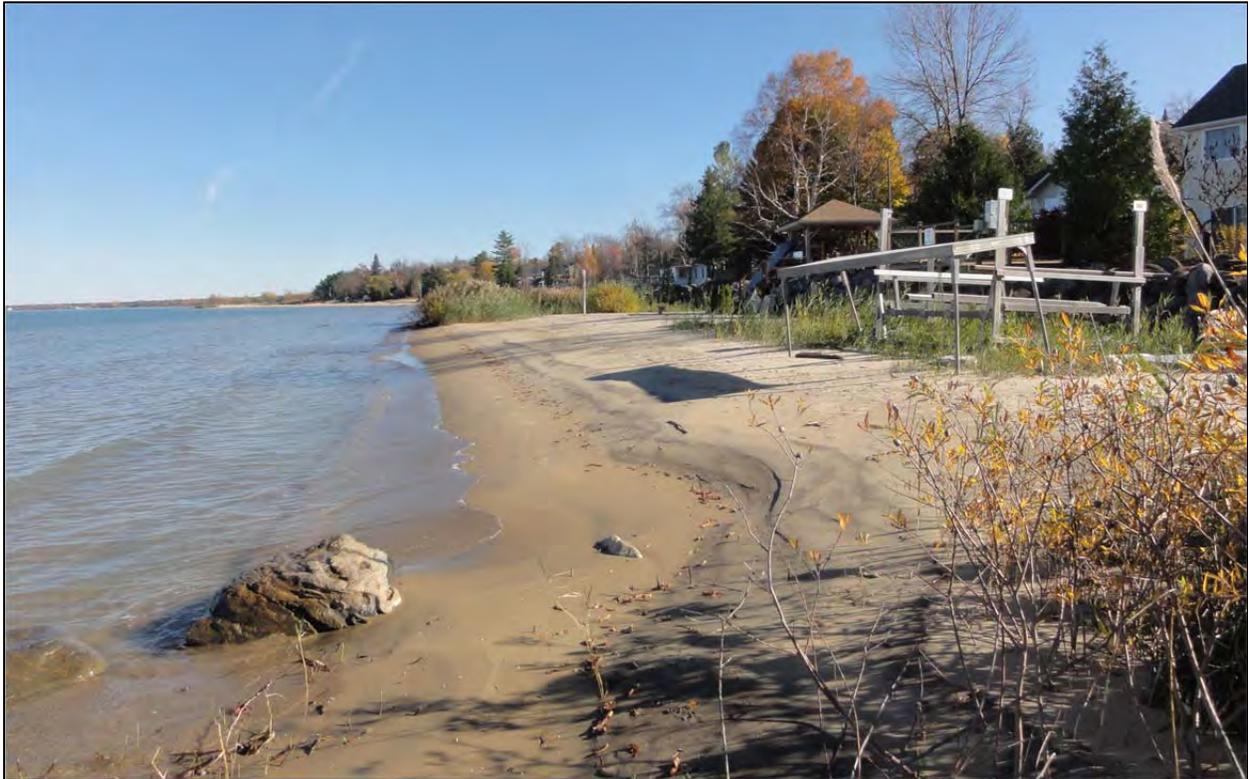
**Figure 4.3 Western End of Western Beach Section**

Figure 4.3 shows an eastern looking view of the of the western beach section, taken from its western boundary. This area consists of a thin sand deposit overlying a cohesive substrate. It is designated as a dynamic beach because it meets the three MNR conditions listed above, but the profile adjustments that will occur at this end of the beach will be constrained by the cohesive substrate. In terms of coastal processes, the cohesive shore is the controlling substrate. A site specific detailed analysis could show that this end of the beach should not be considered to be a dynamic beach. It should also be noted, however, that the dynamic beach allowance at the west end of the western beach section is defined by a cohesive bank and protection structures so the distinction of whether or not this is a dynamic beach shoreline may not have a significant impact on any development proposals.

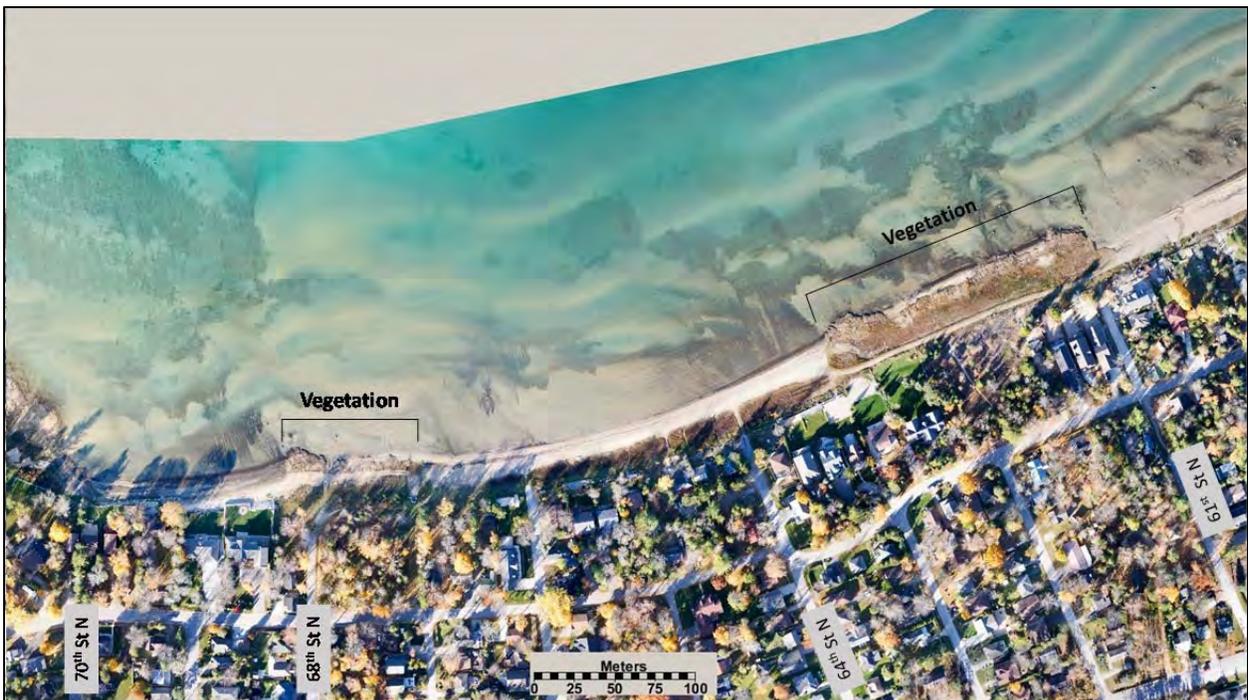
**Figure 4.4 Western End of Eastern Beach Section**

Figure 4.4 is an aerial photograph of the western end of the eastern beach section. As with the

western beach section, the west end of this beach transitions to a cohesive shore and the point at which the dynamic beach becomes a cohesive shore is not clearly defined. Again, however, the dynamic beach allowance here is limited by shoreline structures and a cohesive bank so an exact delineation of the lateral boundary of the dynamic beach may not be important.

Figure 4.4 also shows two vegetated areas where the dynamic profile changes associated with a dynamic beach will be limited due to the vegetation. It is likely that these areas exist because they have not been mechanically raked as elsewhere along the shoreline, but the greater presence of offshore cobbles suggests that the cohesive substrate may be at a higher elevation there. It is possible that a site specific detailed study could argue that these areas are cohesive shores, not dynamic beaches, but for this study we have classified them as dynamic beaches.
